**INDIAN LAKE STONE DAM**

**HAMILTON COUNTY  
NEW YORK**

5 **PHASE I INSPECTION REPORT**

1 **NATIONAL DAM SAFETY PROGRAM**

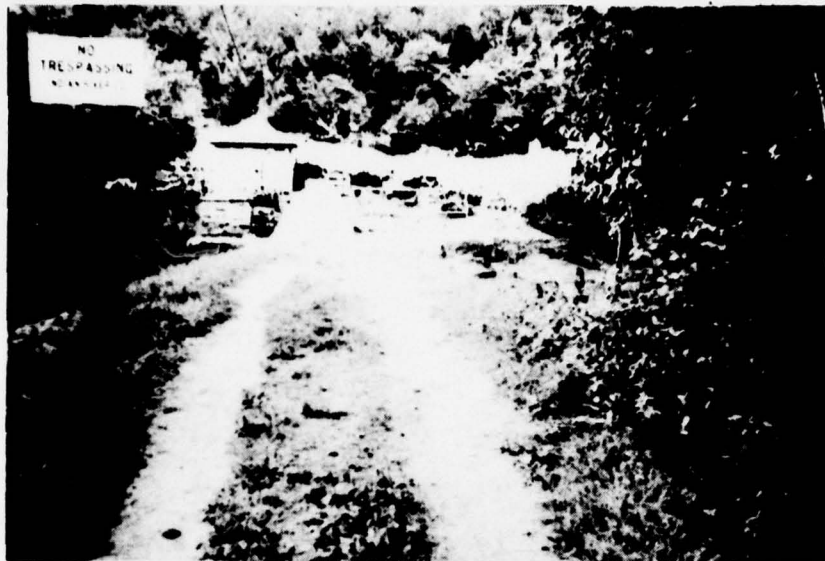
1. View across dam looking north.  
Road surface is on south dam embankment.

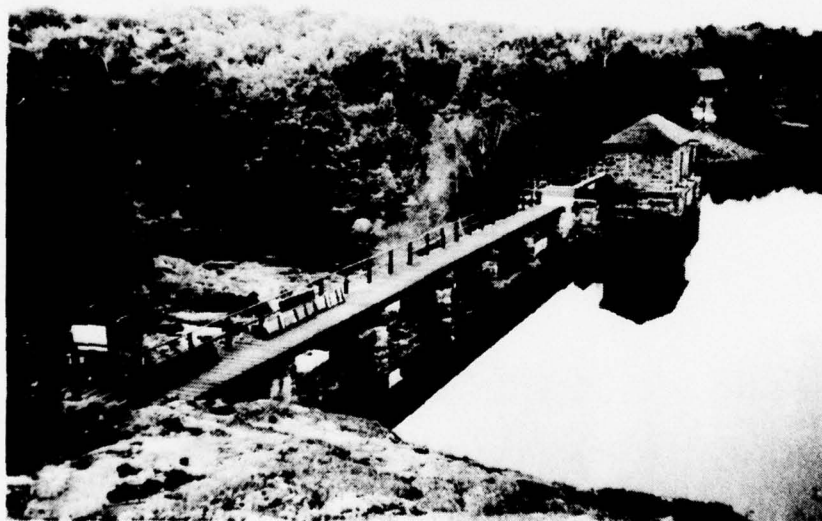
2. View across face of dam from north abutment.

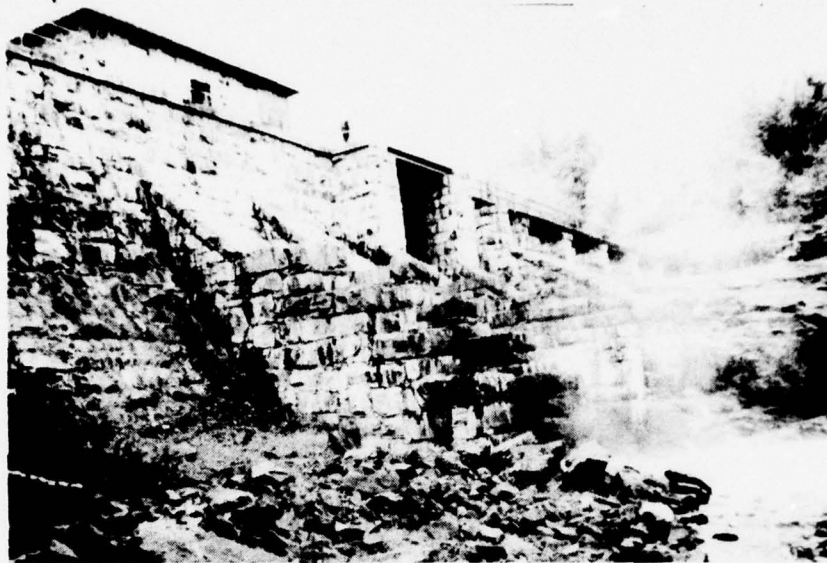
3. View from below dam looking up towards spillway in right portion of picture. Spillway channel is carved out of rock.

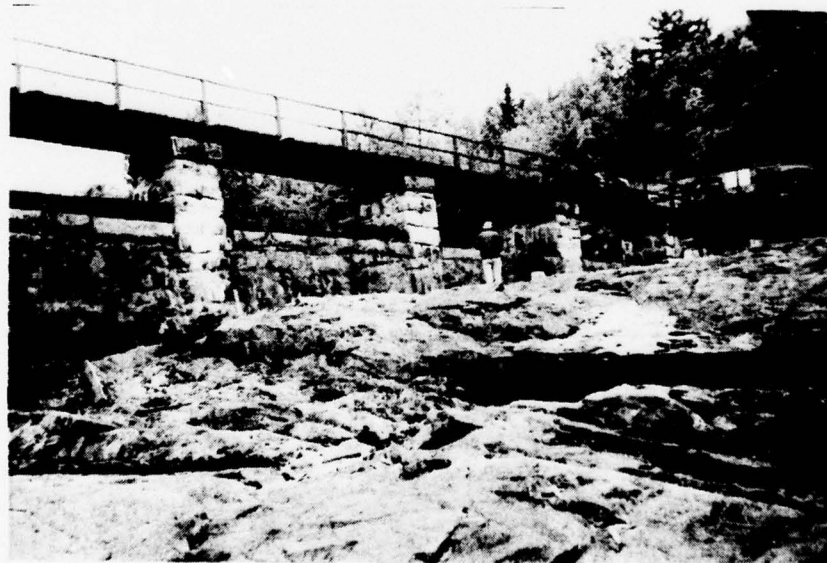
4. View looking up towards spillway crest. Notice 2 flashboards are in place, the others are on top of bridge deck.

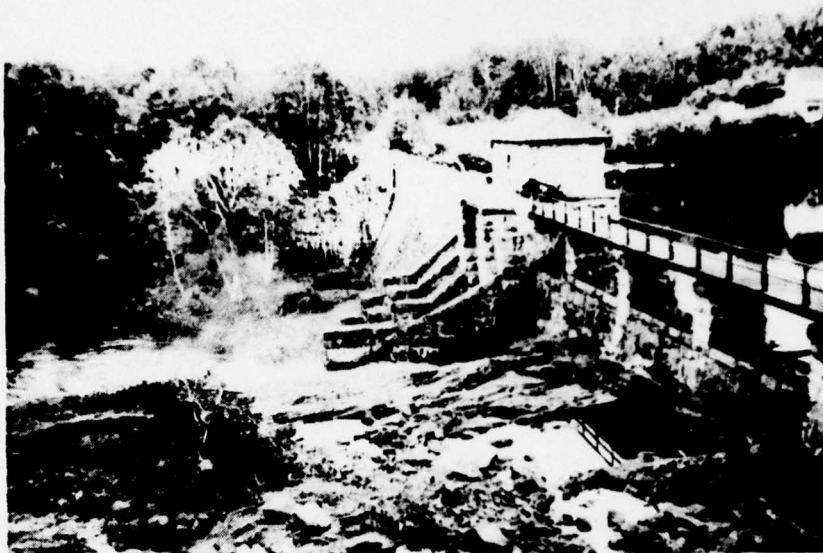
5. View looking down across downstream side of spillway which is benched out of rock so as to direct flows back toward main channel.

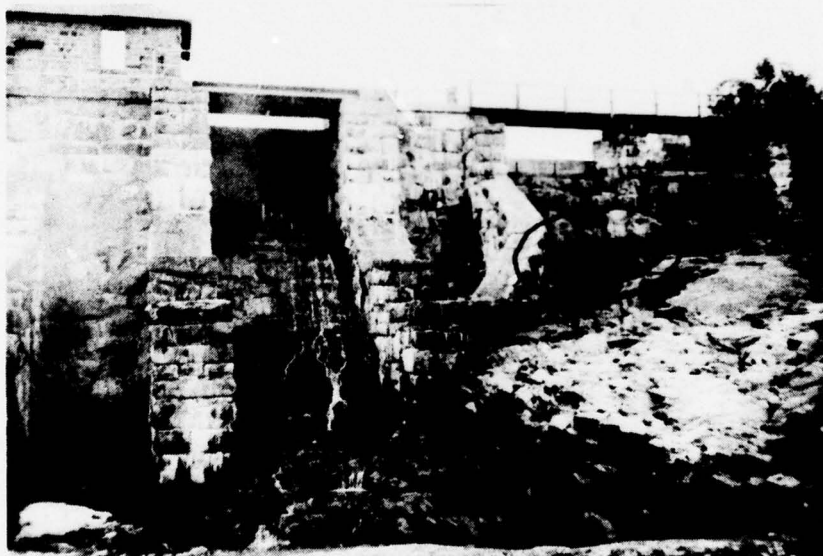
6. Closeup of lower spillway area shows erosion area next to training wall. A soil-cement type material has been placed in the encircled area but it too has eroded. The left center portion of the picture shows a log chute which is reported as not in use. The far left shows one of the two outflow discharge chambers.

A number of additional items observed during the inspection are of concern and need attention. The earthen downstream embankment section is covered with trees that have been long established on the slope. A limited amount of seepage was noted along the downstream toe of the earthfill section near the south abutment and near the point where it abuts the masonry section. The downstream face of the masonry center segment shows considerable evidence that seepage, apparently minor, has been ongoing for a period of time. Masonry buttresses on the dam's downstream side retain stability but undermining has begun at the downstream extremity. There is minor seepage through the masonry in the spillway area. Some erosion of rock has taken place near the south end of the spillway. An area in the spillway channel appears to have been filled with either concrete or soil cement and this repair of the crevice has again eroded leaving a void in the rock surface.

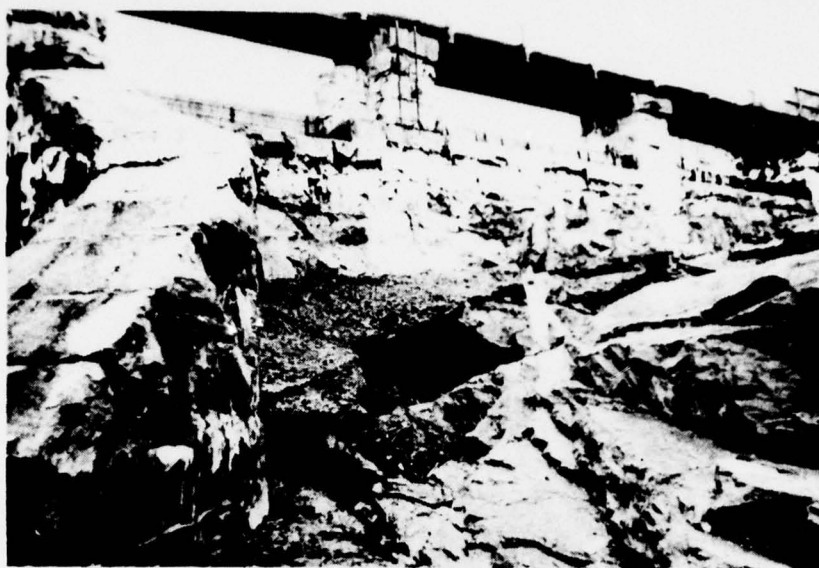
7. A closeup of the encircled eroded spillway channel area shown in Picture #6.

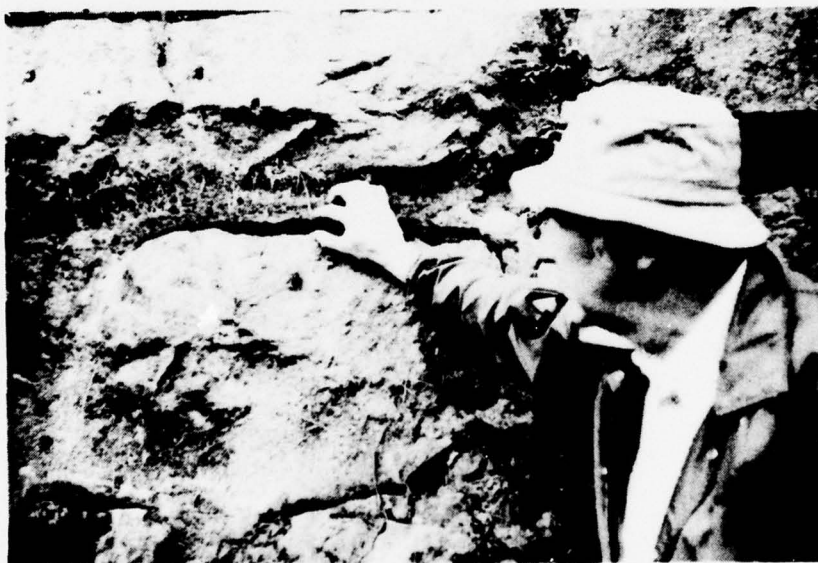
8. Closeup of downstream spillway showing separation in masonry.

VISUAL EXAMINATION OF	OBSERVATIONS	REMARKS OR RECOMMENDATIONS
CONCRETE WEIR (Masonry Weirs only)	Generally in fair condition. Some seepage noted with joints opened up to one inch.	Spillway seepage needs repair.
APPROACH CHANNEL	No separate approach channel. Reservoir discharges directly over masonry wier. Reservoir is shallow in area near wier.	
DISCHARGE CHANNEL	Cut rock surface. Benched down to stream. Significant erosion at south end of spillway. Previously filled with soil, cement has severely eroded.	Eroded spillway section next to dam should be repaired.
BRIDGE AND PIERS	Masonry piers for walkway in good condition. Walkway refurbished this year.

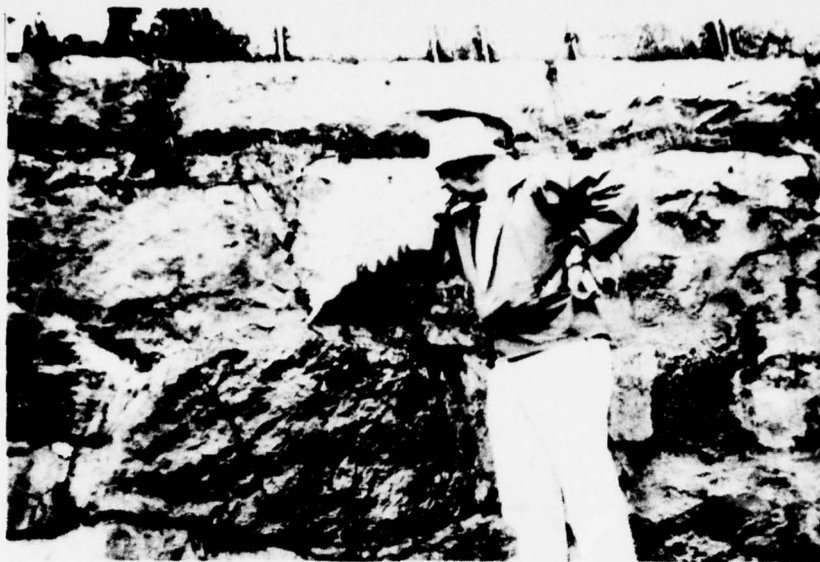
9. Another closeup of spillway facing showing limited seepages through masonry joints.

VISUAL EXAMINATION OF	OBSERVATIONS	REMARKS OR RECOMMENDATIONS
ANY NOTICEABLE SEEPAGE	There is a slight seepage between masonry joints in northern spillway area. The south abutment wing wall has some seepage as well as limited seepage on downstream wall including some calcifications.	
STRUCTURE TO ABUTMENT/EMBANKMENT JUNCTIONS	South abutment wall has seepage with iron oxide deposition. Below and behind the south abutment, considerable wetness (seepage is suspected) was noticed.	
DRAINS	None observed.	
WATER PASSAGES	A log passage closed with steel planks leaks.	
FOUNDATION	See spillway section and outlet section for problem areas. The general dam section did not show any problems.

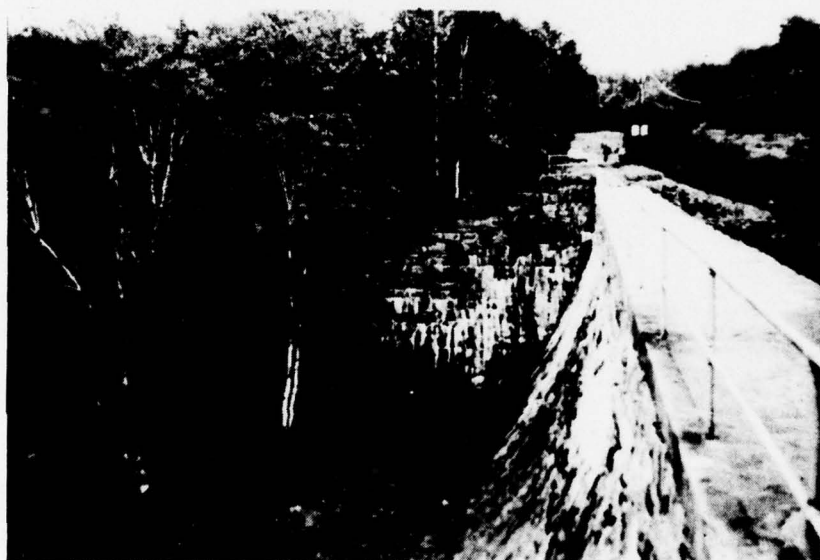
10. View looking south across downstream face of dam. The earthen section originates behind the masonry head wall. Whiteness in the photograph depicts calcium and iron oxide deposition.

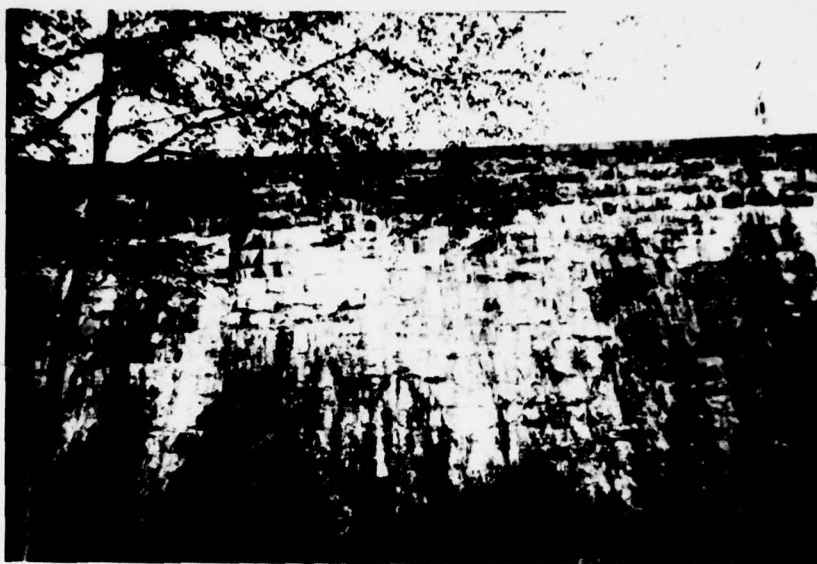
11. Another view of the downstream wall section described in Picture #10.

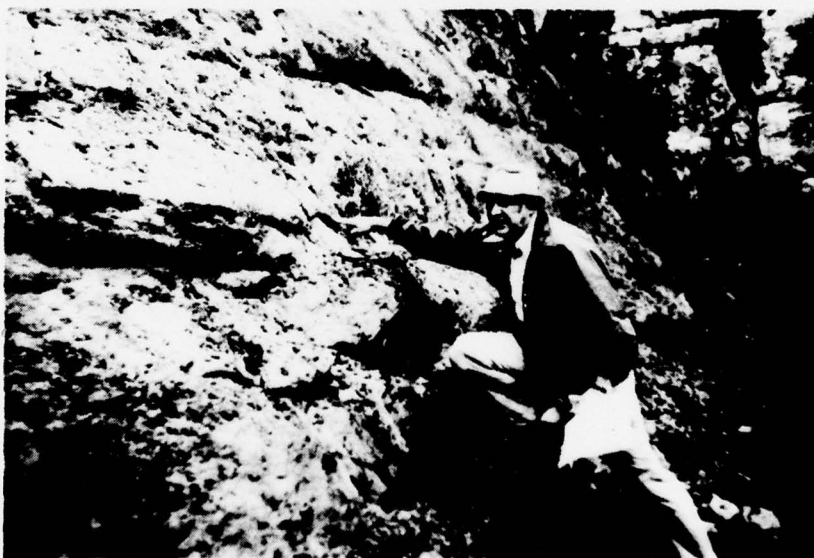
12. Closeup of lower portion of wall showing extent of calcium deposition with limited seepage.

VISUAL EXAMINATION OF	OBSERVATIONS	REMARKS OR RECOMMENDATIONS
SURFACE CRACKS CONCRETE SURFACES (Masonry surfaces only)	Limited seepage, calcification at mortar joints.	Dam could use some pointing of mortared joints.
STRUCTURAL CRACKING	None observed.	
VERTICAL & HORIZONTAL ALIGNMENT	Good condition.	
MONOLITH JOINTS	None.	
CONSTRUCTION JOINTS	None observed.	
STAFF GAGE OF RECORDER	None.

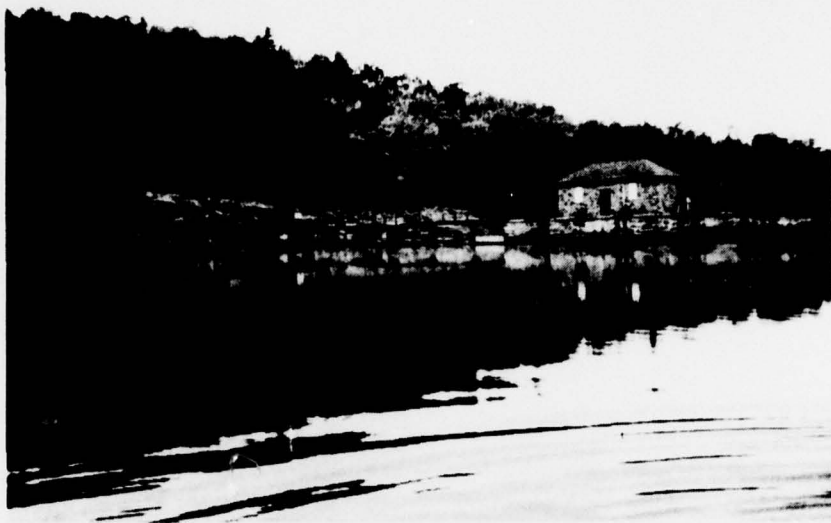
13. Upstream view of spillway.

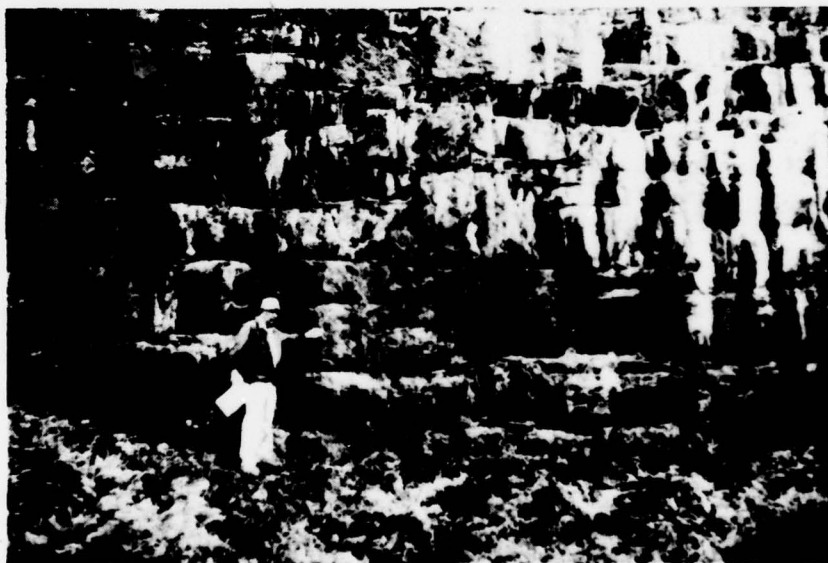
14. Closeup along south abutment.

VISUAL EXAMINATION OF	OBSERVATIONS	REMARKS OR RECOMMENDATIONS
JUNCTION OF EMBANKMENT AND ABUTMENT, SPILLWAY AND DAM	N/A	
ANY NOTICEABLE SEEPAGE	Minor seepage evident at south abutment.	
STAFF GAGE AND RECORDER	None.	
DRAINS	None.

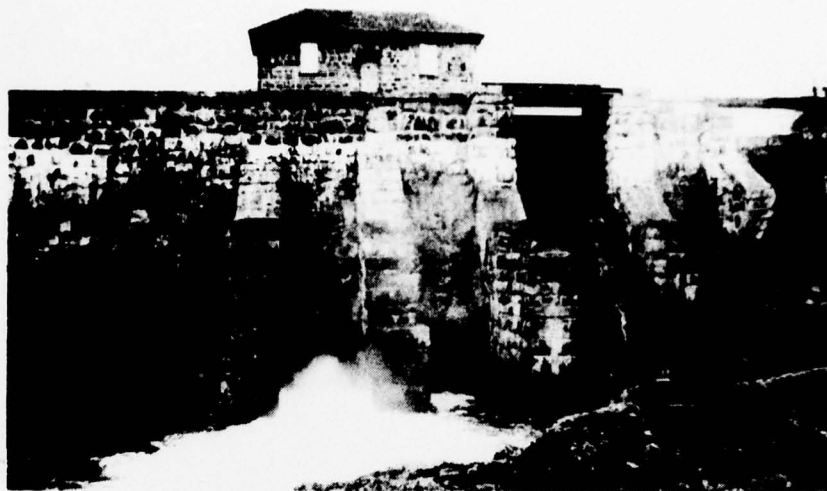
15. Picture of outlet chamber. The left chamber gate is 1 foot open. The right chamber gate is closed.

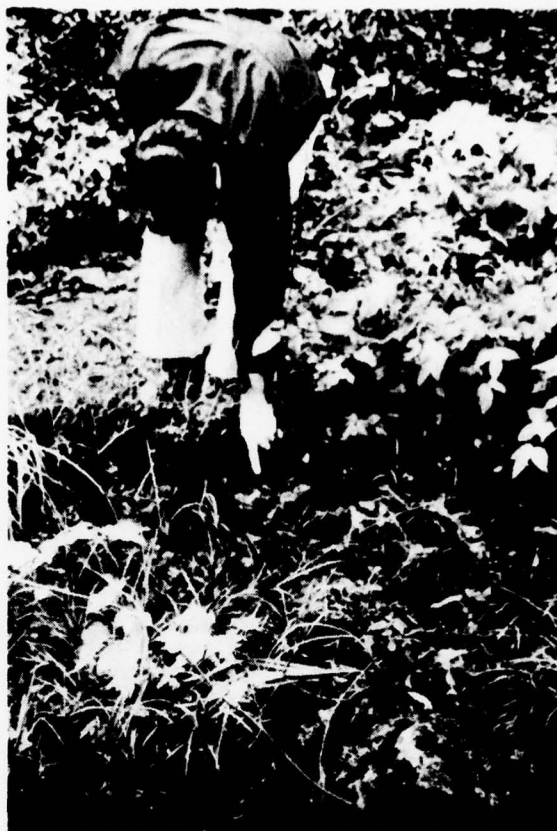
17. Detail of seepage from the ground surface area below headwall. Seepage is occurring over a sizable area. Both under-dam and abutment seepage is suspected.

The earthen embankment section is stable but also shows indication of probable seepage. As for the masonry section, the embankment section should be inspected at frequent intervals to detect a change in conditions which indicate the need for corrective measures. At present, the downstream face of the embankment area has a number of trees growing on it. Seepage may be related to tree growth where seepage paths may have developed along root systems. If this is the case, it may be necessary to make a relatively comprehensive evaluation of alternatives to eliminate seepage and improve the condition of the embankment. Trees should also be removed to prevent the danger of loss of embankment which would occur if uprooting in a high velocity wind storm occurred. The clearing of brush from the embankment area will also permit an inspector to better detect conditions of possible embankment seepage.

The embankment has a large number of trees growing on it which should probably be removed. Seepage may be related to tree growth where seepage paths may have developed along root systems. If this is the case, it may be necessary to make a relatively comprehensive evaluation of alternatives to eliminate the seepage and improve the condition of the embankment.

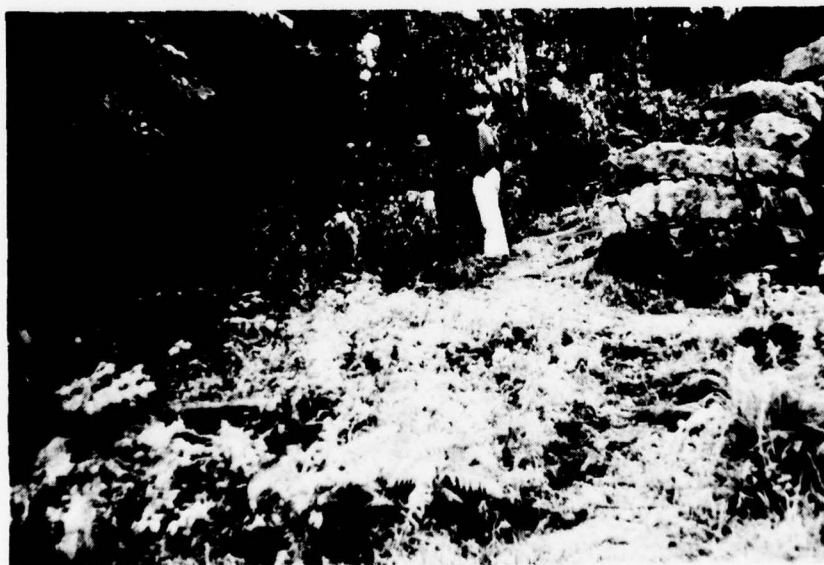
18. Another picture of the seepage area; notice end of headwall. The dam earthen section on the downstream side of the embankment is heavily treed.

The dam's southerly earthen section gives the appearance of being in good structural condition, with no evidence of settlement, sloughing or significant erosion. Surface water was noted on the date of inspection near the embankment's downstream toe in the vicinity of the masonry abutment where the earthen and masonry sections join; this condition may represent seepage through the dam. Seepage also occurs through the exposed face of this abutment. The upstream slope of the embankment section is provided with riprap, observed to be in generally good condition. The downstream slope has developed vegetation which includes some relatively tall trees.

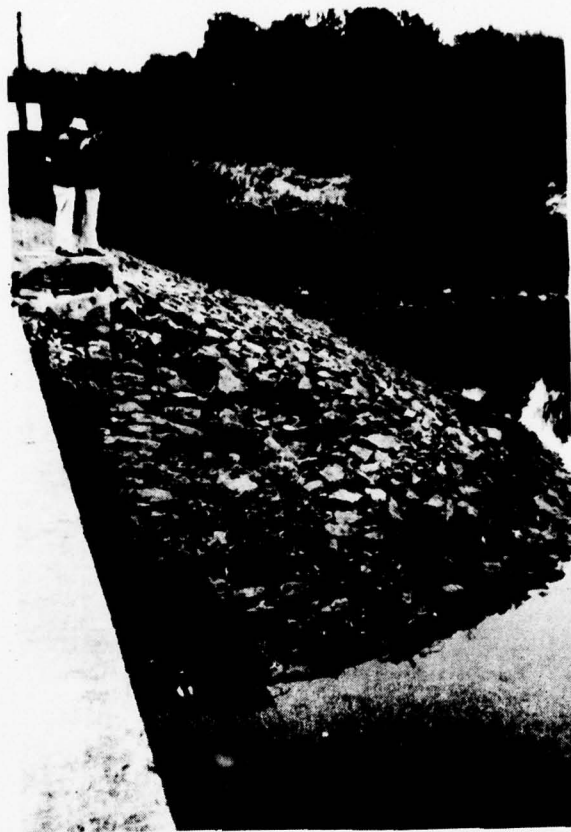
19. The upstream side of the earthen section is riprapped. This picture shows a sloughed area in the riprap in the center of the photograph.

VISUAL EXAMINATION OF	OBSERVATIONS	REMARKS OR RECOMMENDATIONS
SURFACE CRACKS	None.	
UNUSUAL MOVEMENT OR CRACKING AT OR BEYOND THE TOE	None.	
SLOUGHING OR EROSION OF EMBANKMENT AND ABUTMENT SLOPES	Slopes overgrown with trees. No significant erosion or sloughing.	Remove trees.
VERTICAL AND HORIZONTAL ALINEMENT OF THE CREST	Good.	
RIPRAP FAILURES	Minor riprap failure near junction with masonry section of dam.	Repair riprap.
